How/Why Do Sandbars Fail?

By Eric Booth

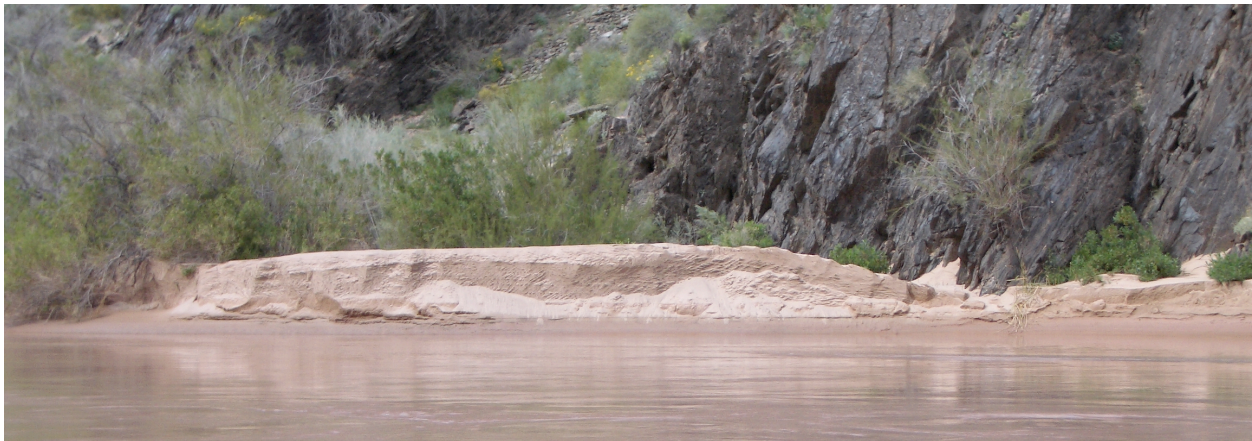
Seepage erosion is a common occurrence in the Grand Canyon due to the enormous fluctuations in flow caused by electricity generation at Glen Canyon Dam. This fluctuation was very large during our journey down the Grand Canyon. Starting January 1, 2005 and ending April 7, 2005, non-native fish suppression flows are released from Glen Canyon Dam and consist of a daily fluctuation of 5,000 cfs to 20,000 cfs. Seepage erosion occurs during the drawdown period when water in the river channel drops at a substantially higher rate than the water within the pores of the sandbar. The rate is substantially higher because the moment a drop in the river stage occurs, there is not an instantaneous draining of the sandbar to even the water levels out due to the small sand particles inhibiting the movement of water. The difference in water level between the river channel and the sandbar increases as the drawdown continues. This increase leads to instability because the pore water pressure in the saturated part of the sandbar no longer has a full river to balance out the pressure forces. Finally, this instability can lead to a Coulomb-type slope failure when the pressure forces are too great and the sandbar shears off into the river channel. These types of failures can be quite devastating and huge areas of a sandbar can be lost in a few seconds.

Figure 1. Coulomb-type slope failure.

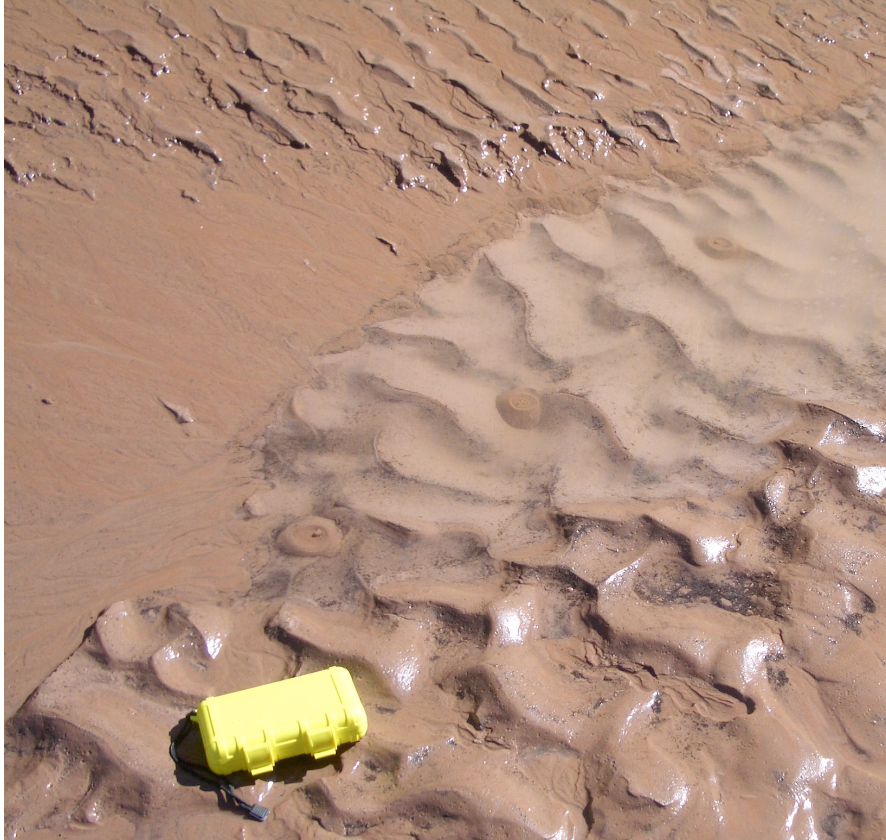
Seepage due to differences in drawdown rates was also observed at the upstream sandbar at Crystal Rapid (RM 98). A video was taken of the boils seeping up from the ground approximately 1 ft above the current low flow level (~8,000 cfs). Figure 4 shows several of the boils within this area at approximately 8,000 cfs. The diameter of the boils was approximately 2-4 inches. Due to fact that this area would be inundated at flows greater than 10,000 cfs and that no natural springs exist at this site from anecdotal evidence, the boils are most likely due to the seepage caused by the intense drawdown of the river stage.

Figure 4. Several boils seeping from the sandbar immediately upstream of Crystal Rapid at a flow of approximately 8,000 cfs (the current low flow level). The yellow case is approximately 6.5 inches by 4 inches.
