# Mining and mining legacies in the San Juan River and tributaries

Abbey Hill

Ecogeomorphology  
Spring 2022 – San Juan  
UC Davis

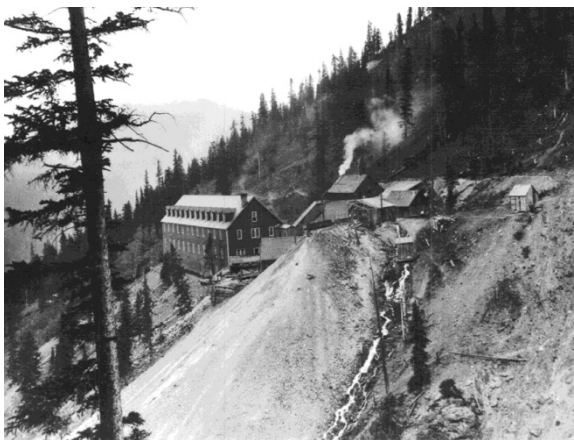
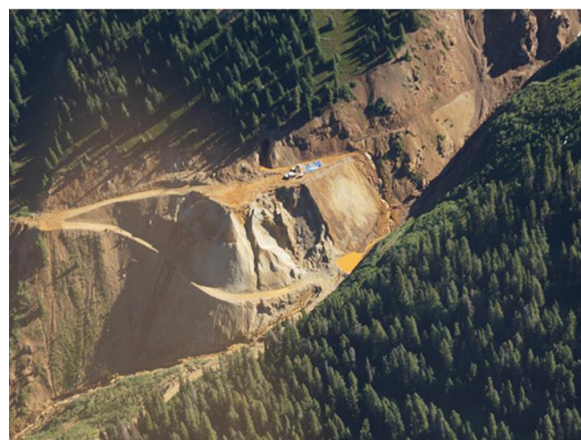
*Figure 2: Historic (a) and post-spill (b) picture of Gold King Mine showing the mine waste pile outside an entrance (Sullivan et al., 2017)*

The Gold King Mine operated intermittently between 1887 until 1922 extracting primarily gold and silver (Sullivan et al., 2017). Figure 2 shows historic and post-spill pictures of the Gold King Mine. The mine was situated upstream of Cement Creek, a tributary to Animas River. The watershed contains several other inactive mines. As stated above, Cement Creek has a pH regularly below 4.5 (Sullivan et al., 2017). As a result of the low pH and other water quality issues directly relating to mining legacy, Cement Creek supported little to no aquatic life (US Geological Survey, 2007a).

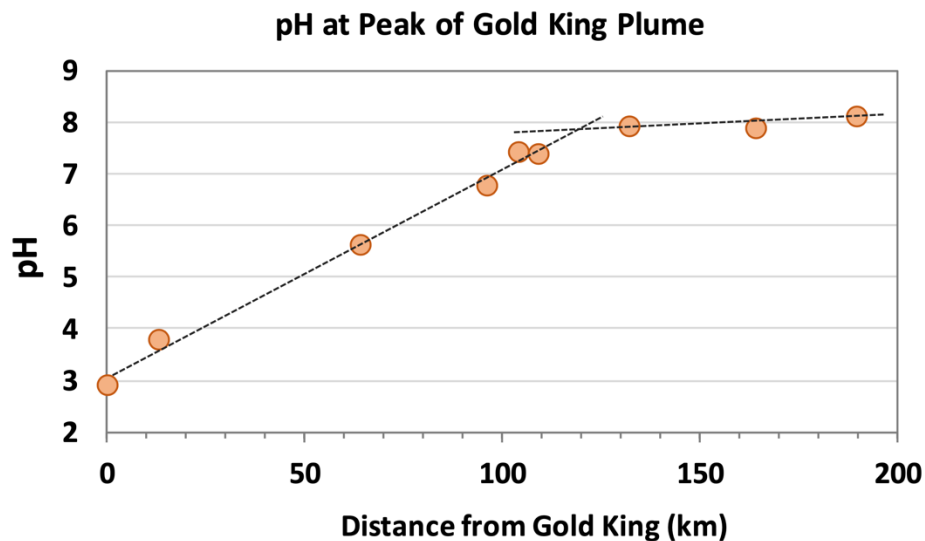
Figure 3: pH at Peak of Gold King Mine Spill Plume (Sullivan et al., 2017)

The pulse was similar in volumetric flow to 1 to 2 days of high spring runoff, but the metals concentrations were far higher than such an event (Sullivan et al., 2017). The original plume likely had a pH as low as 3 (Sullivan et al., 2017). As the plume traveled downstream the acidic water was diluted and eventually mixed with the basic waters of the Animas River. This increased the pH, as illustrated in Figure 3, as the plume traveled further from its origin.

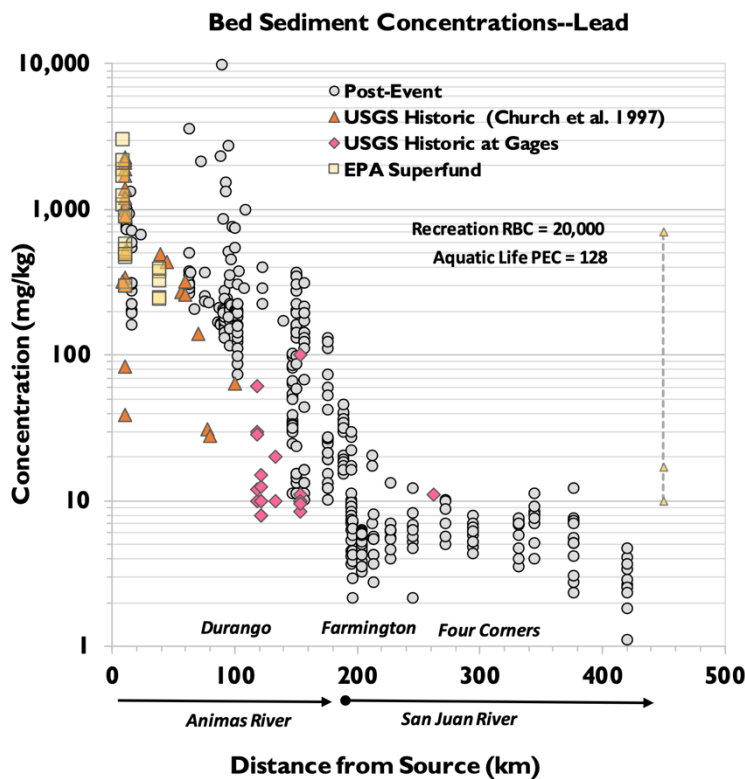
Figure 5: Bed sediment concentrations in the Animas and San Juan Rivers (Sullivan et al., 2017)

The decrease in metals suspended in the plume meant that the metals were deposited in the riverbed (Sullivan et al., 2017). Figure 5 shows that sediments downstream of the spill were consistently higher post-event. Figure 5 also indicates that river bed sediments were highest around Durango (100 km from the source). Figure 3 shows that around 100 km from the source the pH increased to about 7. The concurrence between these two plots and our understanding of physical-chemical processes shows that the change in pH around Durango precipitated metals out of the plume and deposited them in the river bed.
