Riparian Vegetation Responses to Altered Disturbance Regimes in the Grand Canyon

Alma Wilcox

Environmental Policy and Management M.S. Candidate

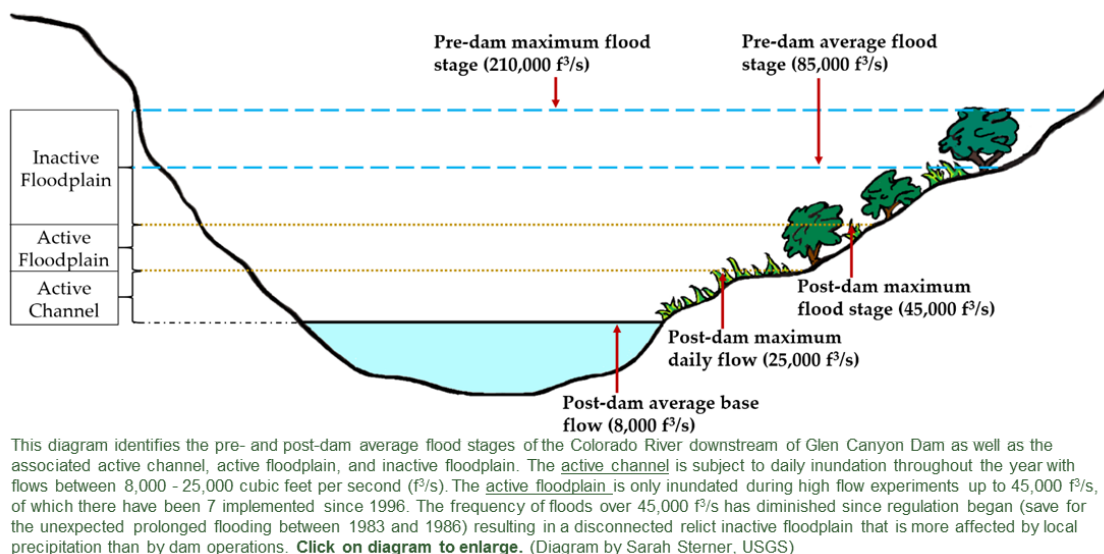
Cross section of the Colorado River channel identifying flood stages before and after the establishment of the Glen Canyon Dam

Figure 2. A cross section of the Colorado River channel labeled with the different flood stages before and after the establishment of Glen Canyon Dam (Sterner, 2018).

Ralston, et al. describes the three portions of the floodplain that are based on dam releases: the active channel, the active floodplain, and the inactive floodplain, displayed above in **Figure 2** (Sterner, 2018 and Ralston, et al., 2014). The active channel is the area of shoreline that experiences the daily operations of the dam flows (Ralston, et al., 2014). The active floodplain is the portion of shoreline that experiences periodic flooding of varied durations and magnitudes outside of the daily dam flows that the active channel experiences (Ralston, et al., 2014). Finally, the historical, or inactive, floodplain is the portion of shoreline that has not received water from Glen Canyon discharges since pre-dam flows (Ralston, et al., 2014). As it was previously described in the *Long-Term Experimental and Management Plan Final Environmental Impact Statement* published by the USBR in 2016, Scott, et al., found that pre-dam water flows were so frequent and high in magnitude that the majority of the active channel, prior to the 1960s, was devoid of vegetation (Scott, et al., 2018). There is documentation as early as the 1980s, that describes the widespread establishment of riparian vegetation post-dam on the formerly active channel downstream of the Glen Canyon Dam (Scott, et al., 2018). There was a period of high flows in the late 1980s, on behalf of hydroelectric power generation, that provided an interesting look into the

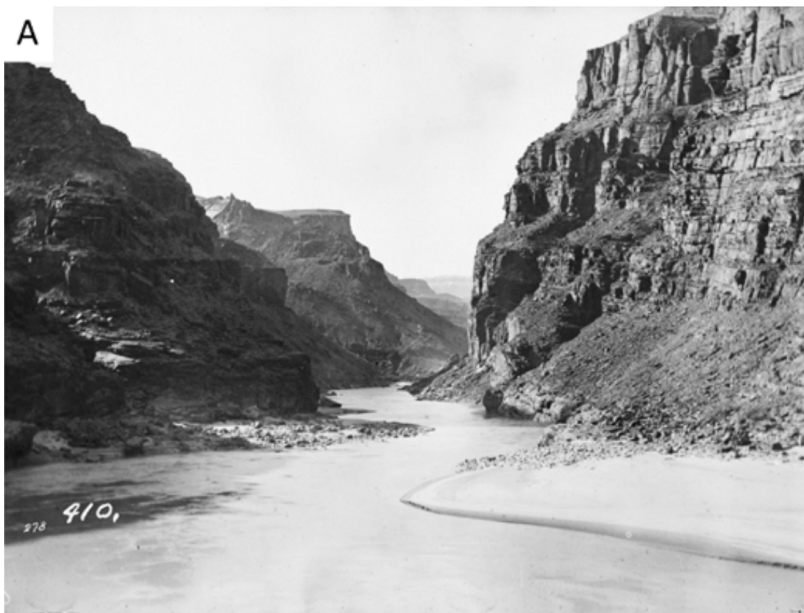
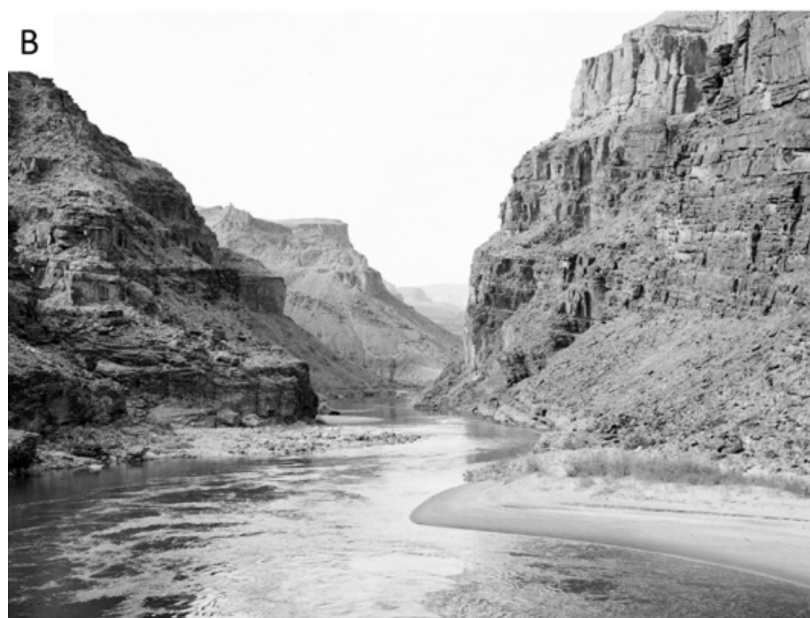
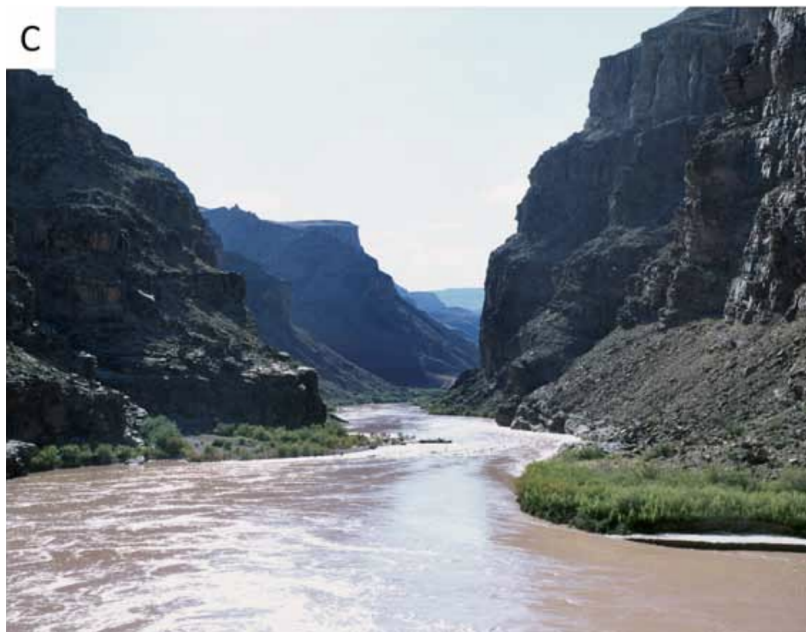
Figure(s) 4. A set of three photographs taken in the Upper Grand Canyon in (A)1890, (B)1991, and (C) 2011, portraying vegetation encroachment (Scott, et al., 2018). Tamarisk is shown in photos B and C to increase in size and number (Scott, et al., 2018). Native vegetation present in this photograph includes sand-bar willow, arrow-weed and seep-willow (Scott, et al., 2018).

This research by Scott, et al., contributed heavily to riparian vegetation research (Scott, et al., 2018). Based on their photographic analysis, they found that Tamarisk was found in 79.5 percent of the views that they examined from 1989 to 1992 (Scott, et al., 2018). Furthermore, between 2010 and 2012, there was little apparent change to vegetative composition (Scott, et al., 2018). Their research can be used as a reference for future research to predict changes in riparian vegetation changes in times of drought, resulting in low flows.
