How/Why Do Sandbars Fail?

By Eric Booth

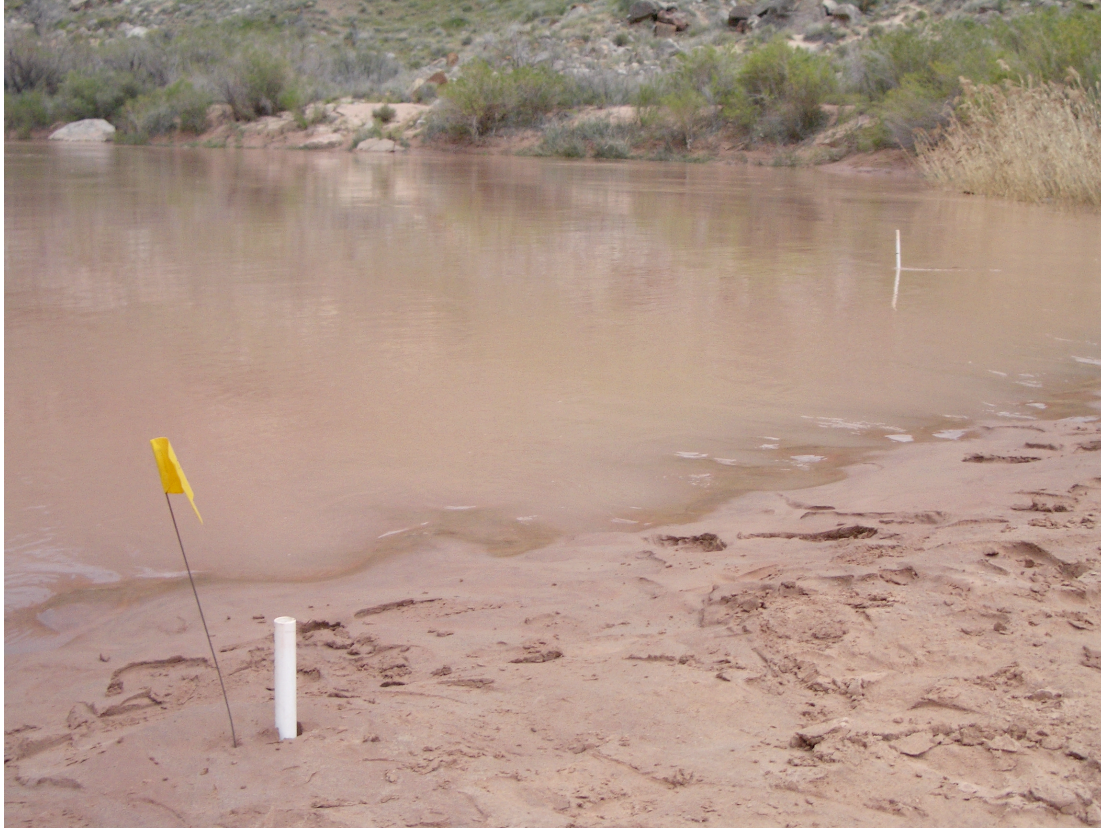
In order to better understand the phenomenon of seepage erosion, the differences between river stage and sandbar stage were observed during drawdown at RM 123L. The stage in the river channel was measured by a PVC pipe driven into the channel bottom with 0.1 foot graduations drawn onto the outside to read. The stage of the sandbar was measured using a shallow piezometer made from a 6-ft section of 2" PVC pipe. At this site, the piezometer was

driven into the sandbar at the current high flow level (~21,000 cfs), which was approximately 11.5 m away from the current low flow level (~9,000 cfs). See Figure 2 for a picture of the site setup. Figure 3 shows the stage readings through time and shows a significant difference in the rate of drawdown between the river and the sandbar. Once the river stage bottomed out at 1 foot, the sandbar stage was almost 3 feet higher in elevation. Even though this site did not experience slope failure, the basic principles behind seeing the significant difference in rates of drawdown can be used for most sandbars in the Grand Canyon.

Figure 2. Setup of experiment to measure river stage and sandbar stage fluctuations during drawdown.

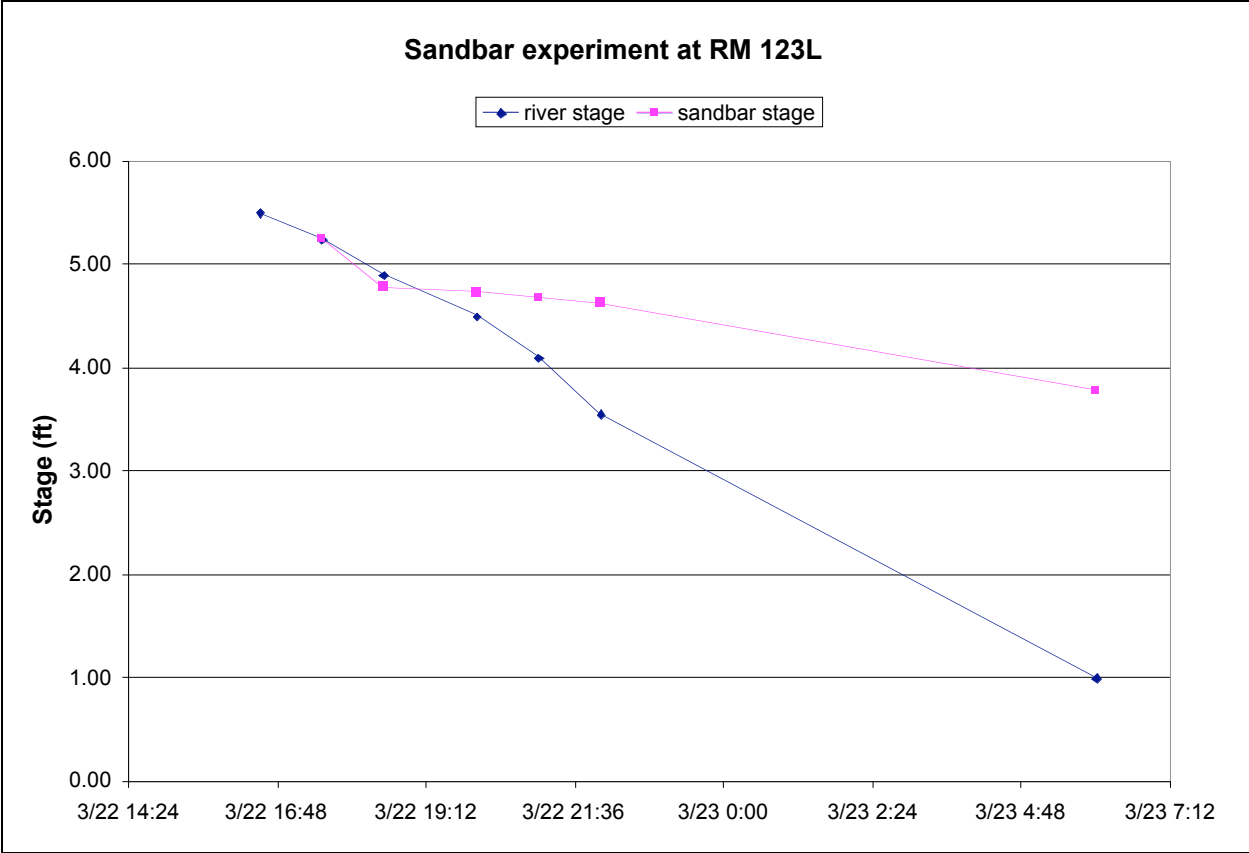
Figure 3. Change in stage with time for the river channel and the sandbar.
