Constriction Ratios Observed on the Colorado River **By Eric Buer**

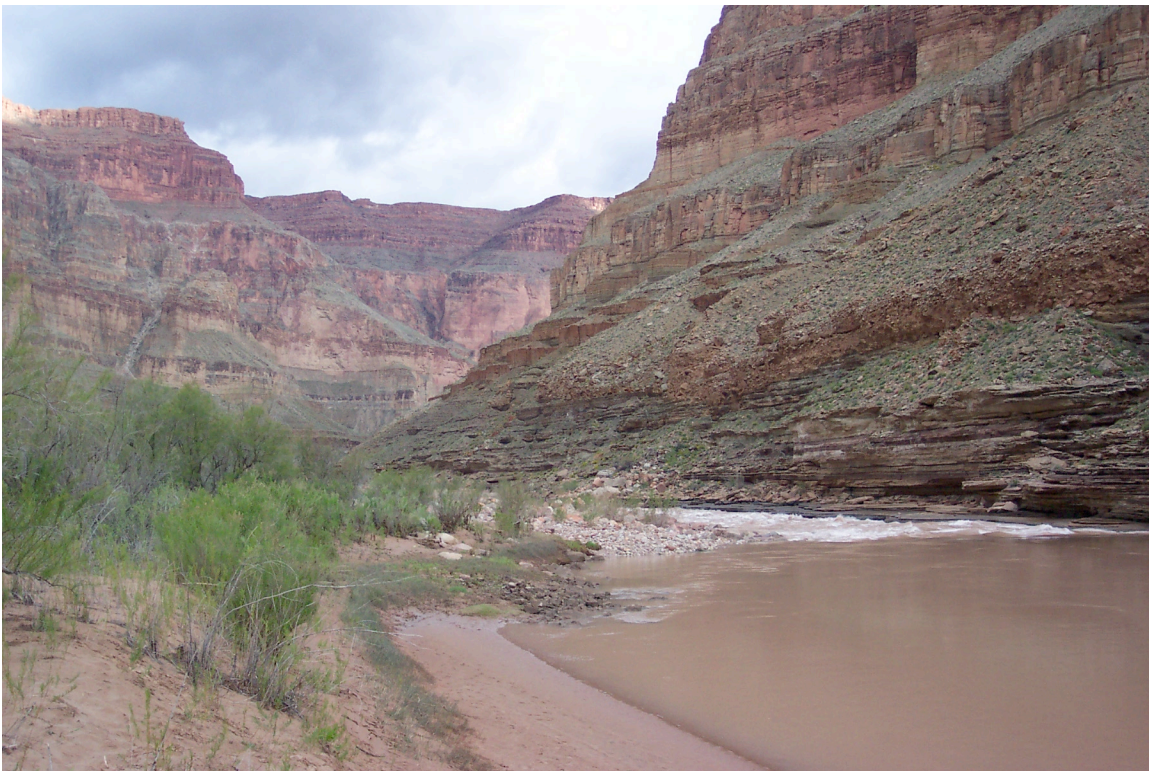
Figure 1. Looking downstream at Forrester Rapid constriction of the mainstem is visible.
(Photo: E. Buer)

Over the course of our trip I was able to measure constriction ratios twice at Forrester Rapid and Fishtail Canyon Rapid. Using a laser I was able to accurately measure the horizontal distance to the opposite side of the river. By choosing points roughly at my eye level, I minimized additional variation in length and was able to obtain relatively consistent measurements.

As the data shows, both of the debris fans which I measured constricted the river to roughly half the width of the mainstem immediately upstream. This supports Kieffer’s assertion that stable fans have reached roughly this value since the fans which I measured both lacked recent aggradation from debris flows and have not changed in recent years.
